NEXUS / MIWA DOOR CONTROL UNIT for AWH Readers Fault & Installation – Diagnosis

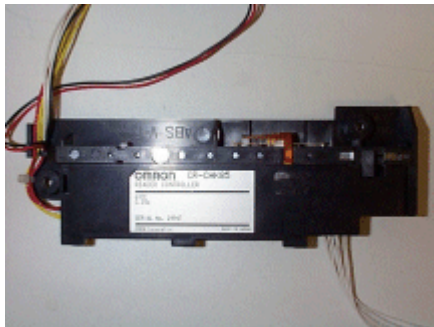
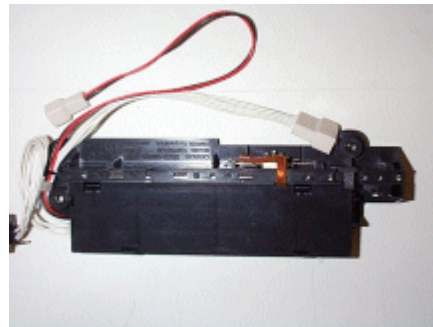
1. Install the short escutcheon, which contains the card reader. Check to ensure the correct reader is installed, as it must be the same type as all the other locks on the system. Miwa supply two different types as follows:

GM9 – (model CR-CHK85)

M10 (No label on back)

- Wrong type of reader has been installed. Check type GM9 or M10 matches software in the DTU.
 - GM9 = Psion DTU software ver 131.
 - M10 = Psion DTU software ver 129.
